**ESECMaSE**

**Enhanced Safety and Efficient Construction of Masonry Structures in Europe**

**D 3.0.2 Stress-strain-relation of perforated bricks (4-brick-specimen)**

University of Kassel  
Institute of Constructive Engineering  
Chair of Structural Concrete  
Kurt-Wolters-Straße 3  
34109 Kassel

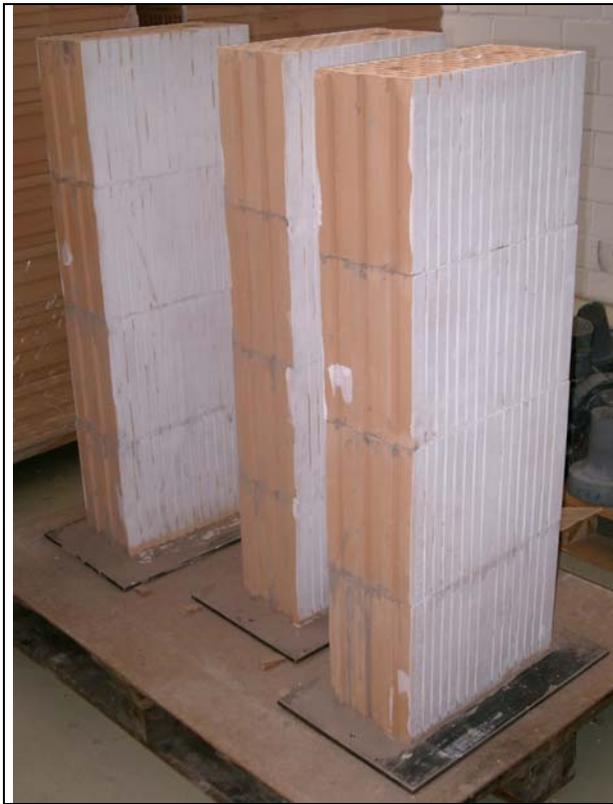
figure 1: masonry specimens

To build up the specimens, a mortar roll has been used. In order to facilitate the use of the mortar roll and to reflect the situation at a real building site, all four bricks were laid down one behind the other into one line, so that the mortar could be applied in one working step on all units. Afterwards the bricks were laid on top of each other.

The masonry specimens were built up on steel-plates in order to enable transport into the testing machine (see figure 1 and figure 2).

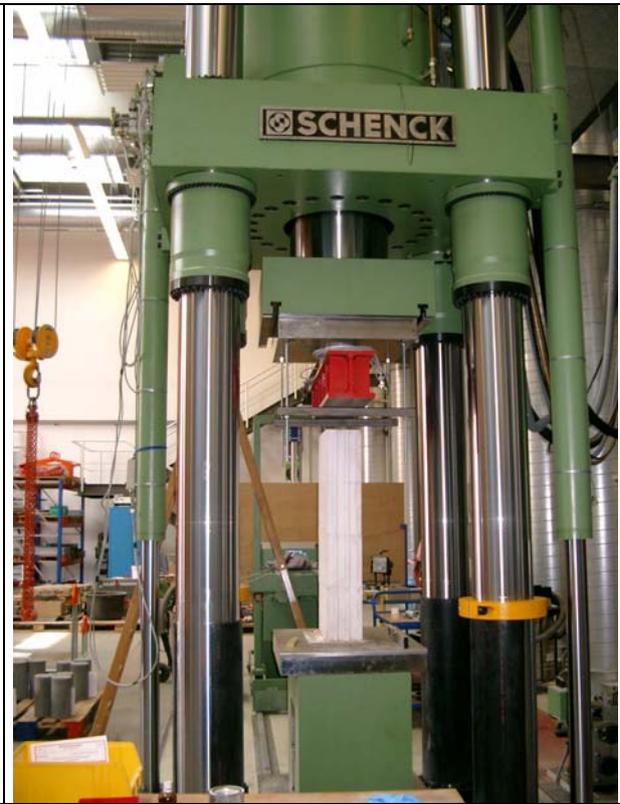
figure 2: testing machine (lateral view)

The specimens have been tested in a 6.3 MN hydraulic testing machine. In order to obtain sufficient accuracy of the load measurement, two 500 kN load cells have been used in addition to the load cell of the machine. The load cells have been positioned between the upper loading plate of the testing machine and the load inducing beam.

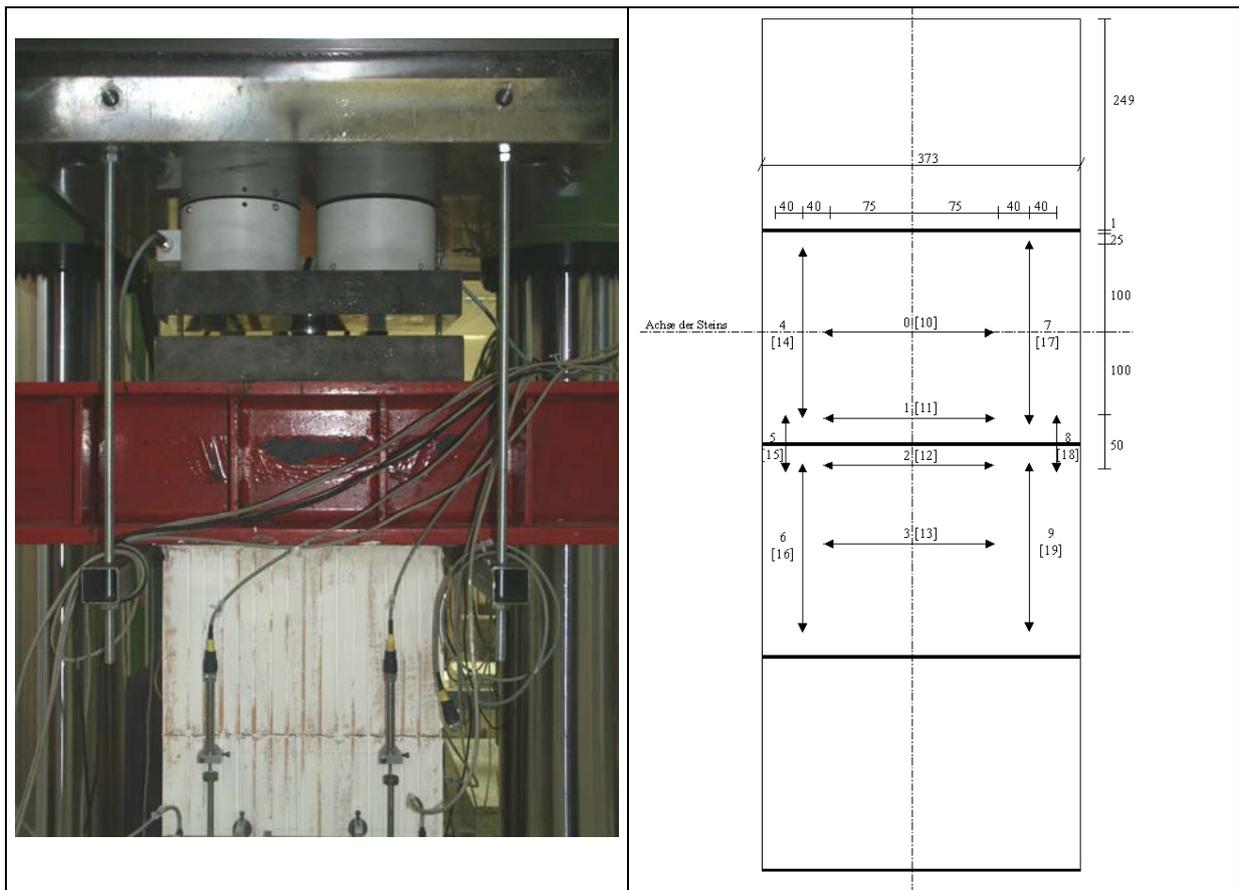
figure 3: load application

figure 4: arrangement of the displacement transducers

For the second series a hinge between the load inducing beam and the two load cells (see figure 3) has been used in order to ensure centric loading.

For measuring deformations 20 inductive displacement transducers (LVDTs) have been installed. They were arranged in an symmetric pattern on the two middle bricks. The arrangement allows to measure longitudinal deformations both of the bricks and in the joint region as well as transverse strains (see figure 4).

The horizontal deformations of the bricks have been recorded by four inductive displacement transducers in the centre of the two blocks (at half the height of the middle blocks) and by four other ones in a distance of 25 mm above and below the middle joint as shown in figure 4.

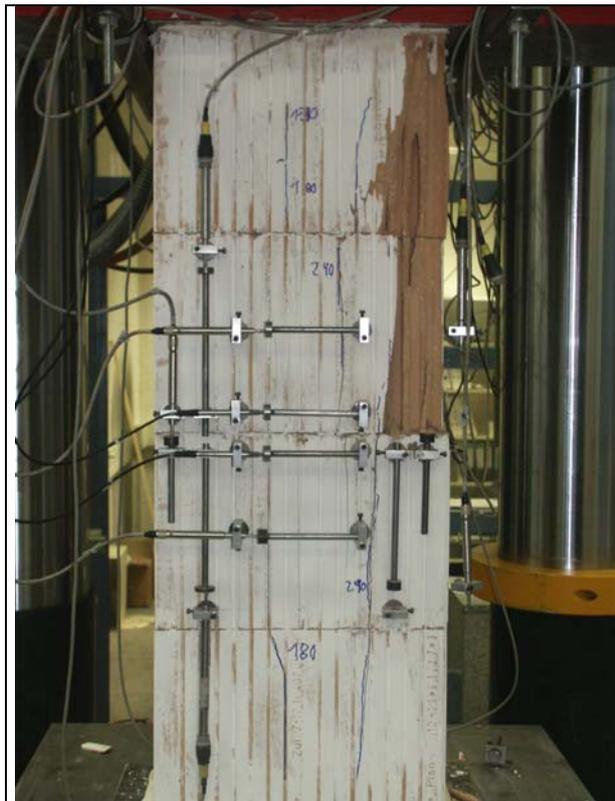
figure 5: destructed specimen

The three masonry specimens of the second series began to show cracks at a stress between  $2.0 \text{ N/mm}^2$  up to  $2.5 \text{ N/mm}^2$ . Further cracks developed until a stress of about  $3.5 \text{ N/mm}^2$  had been reached. From this stress on, which is about the half of the ultimate stress, only a few small cracks appeared almost up to the ultimate stress. The failure of the specimens happened by breaking out of pieces of the perforated bricks, which broke suddenly. By this the load could not be raised further.

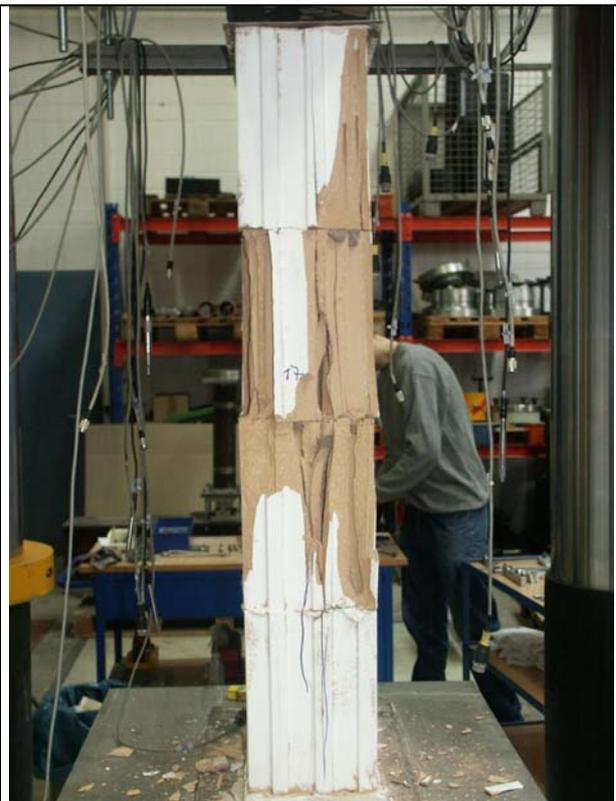
figure 6: face side of MWK 5

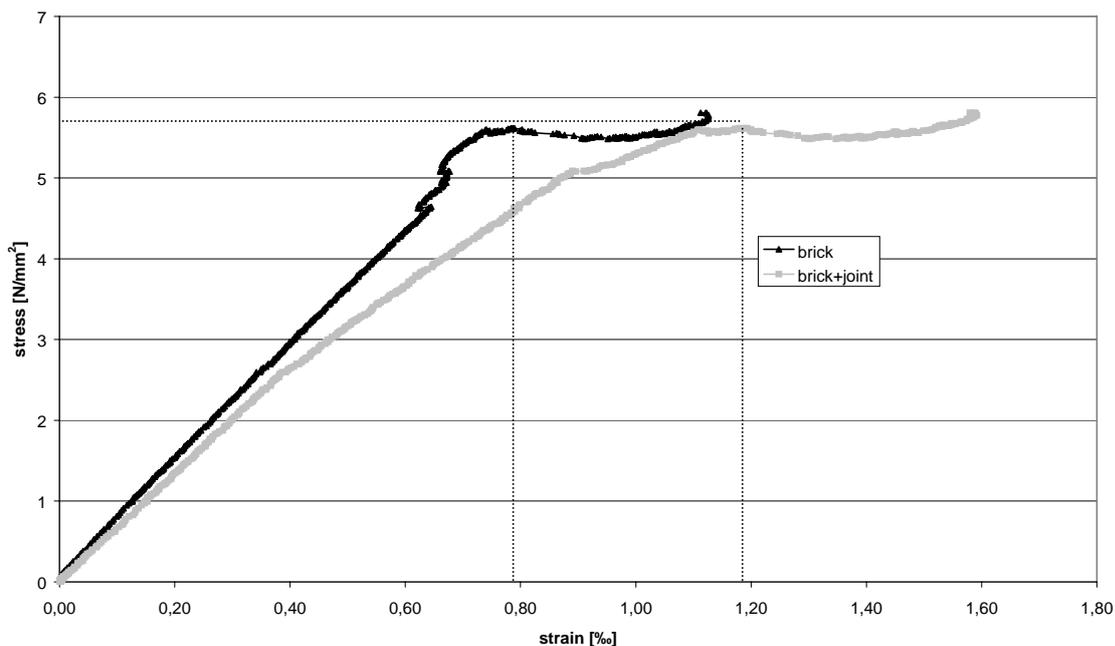
figure 7: stress-strain-behaviour (vertical elongation) of specimen MWK\_1

The three specimens of the first series show an approximately linear elastic behaviour up to the ultimate stress.

For specimen MWK 1, ductile behaviour after reaching the strength is obvious from Figure 7.

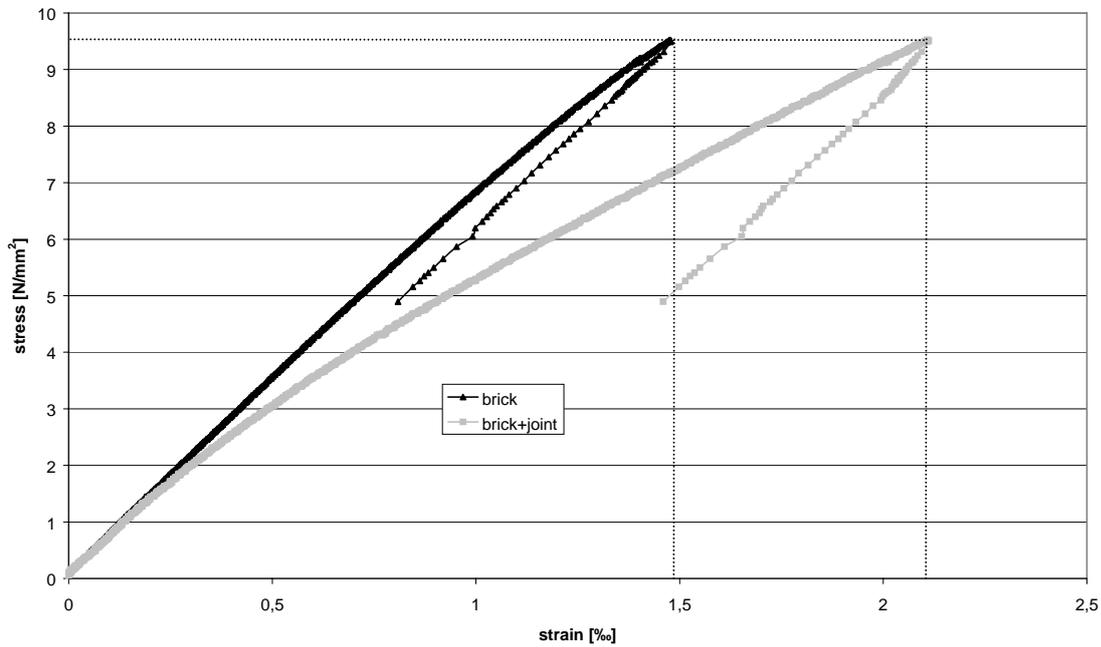
figure 8: stress-strain-behaviour (vertical elongation) of specimen MWK\_2

For specimens 2 and 3, the failure of the masonry column occurred outside of the measurement range. No information on the post peak behaviour is available so far for these specimens.

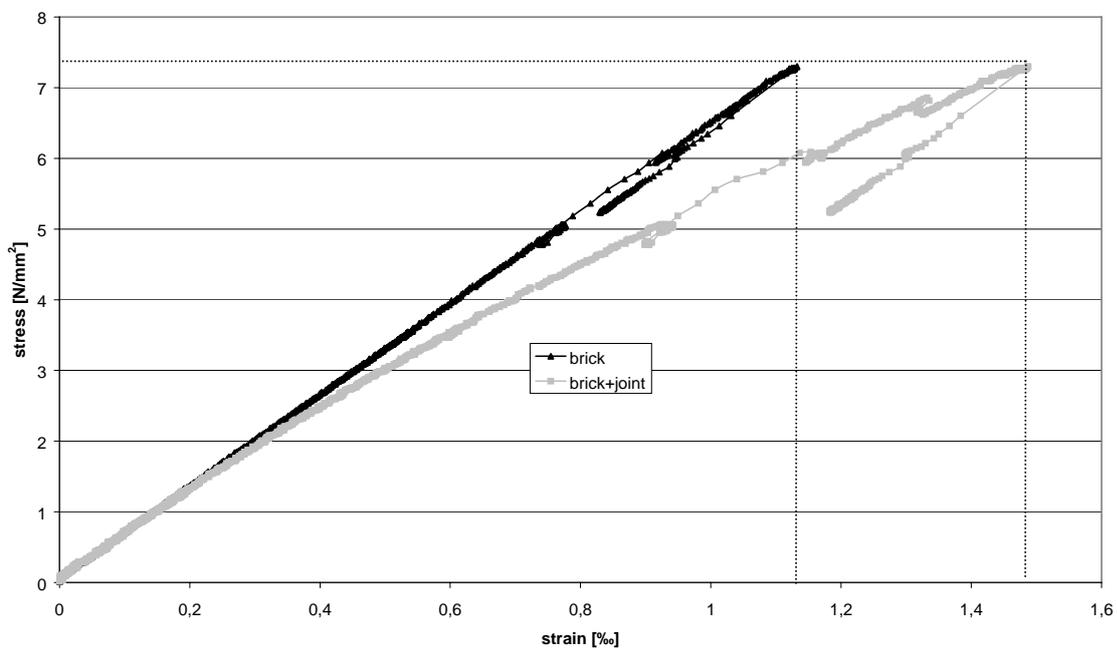
figure 9: stress-strain-behaviour (vertical elongation) of specimen MWK\_3

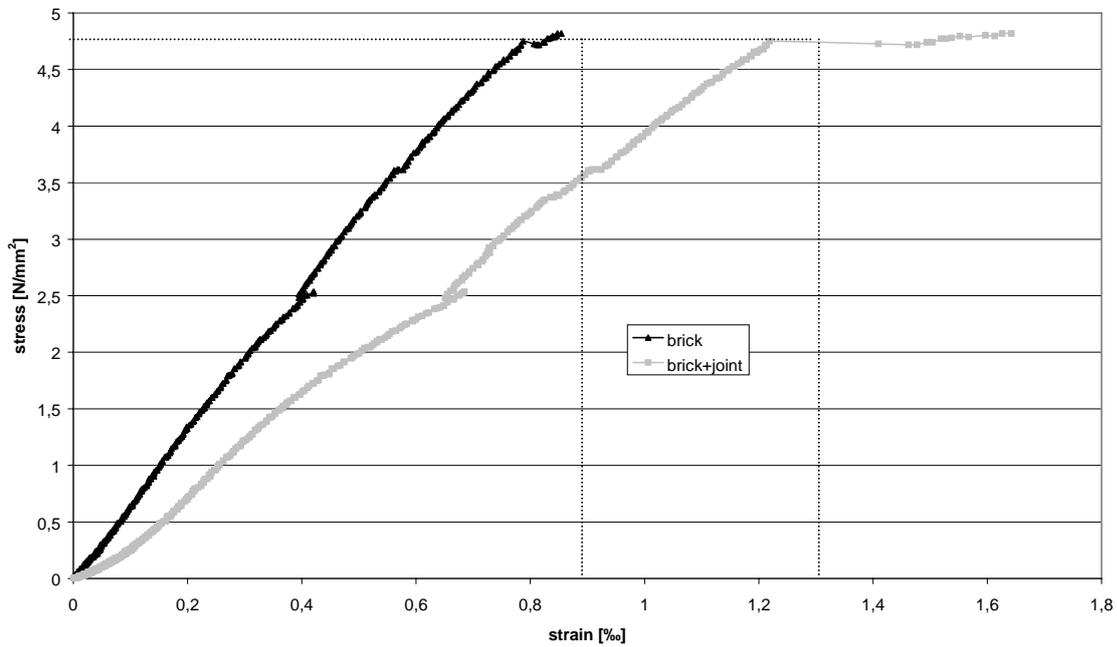
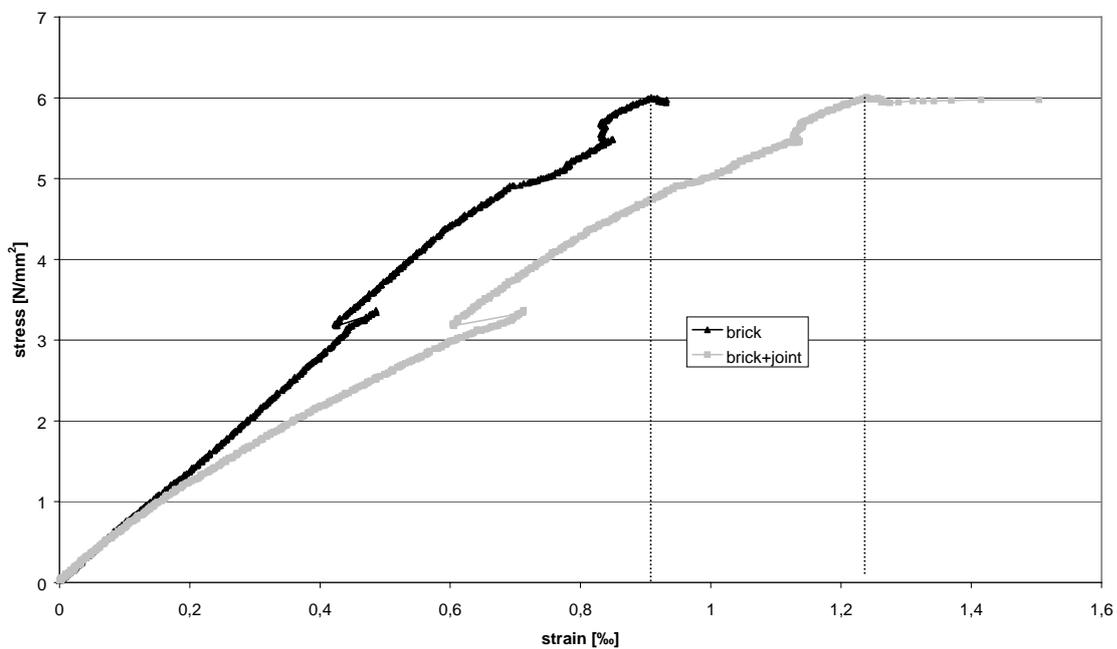
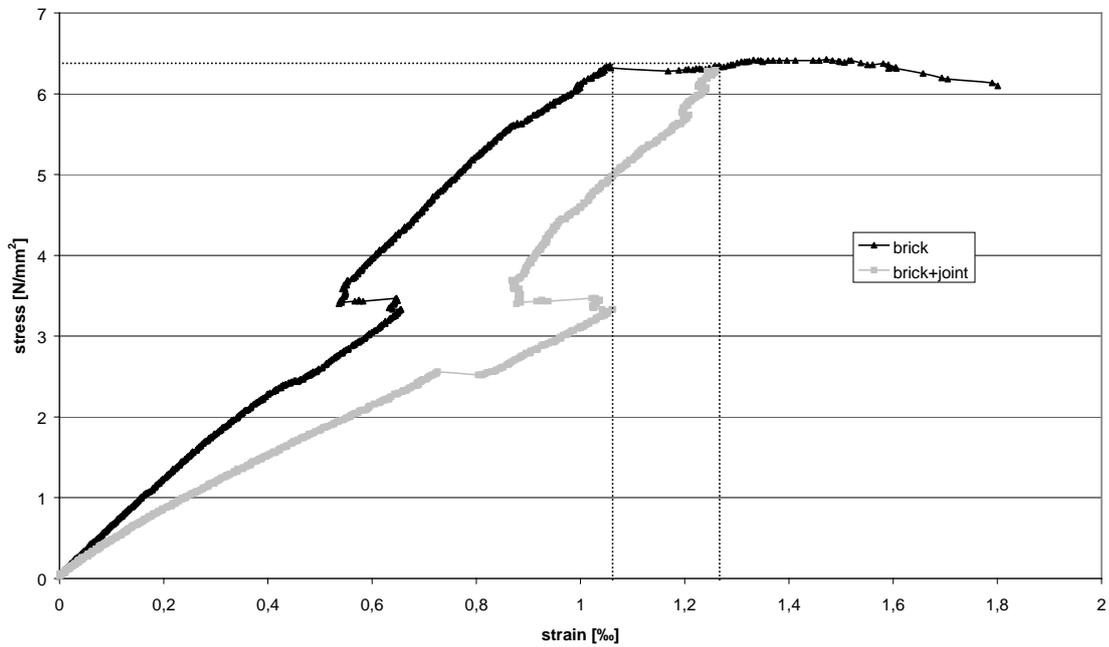
figure 10: stress-strain-behaviour (vertical elongation) of specimen MWK\_4

figure 11: stress-strain-behaviour (vertical elongation) of specimen MWK\_5

figure 12: stress-strain-behaviour (vertical elongation) of specimen MWK\_6

At about half of the ultimate strength, a certain drop of the axial force (and thus: average stress) can be observed from the stress-strain-diagrams of the specimens of the second series can be observed. This can be explained by the appearance of cracks leading to a stress redistribution inside the specimens. However, the overall deformation of the specimens did not decrease. This has been checked by comparison with the path of the measured machine displacements.

All specimens of the second series show a relatively ductile behaviour after reaching the ultimate strength. They are able to keep the ultimate load during increasing deformation although existing cracks enlarge and parts of the blocks break away in a brittle manner. However, no significant increase of load is possible any more in this phase. Whereas the overall behaviour may be called ductile, locally the failure is of brittle nature.

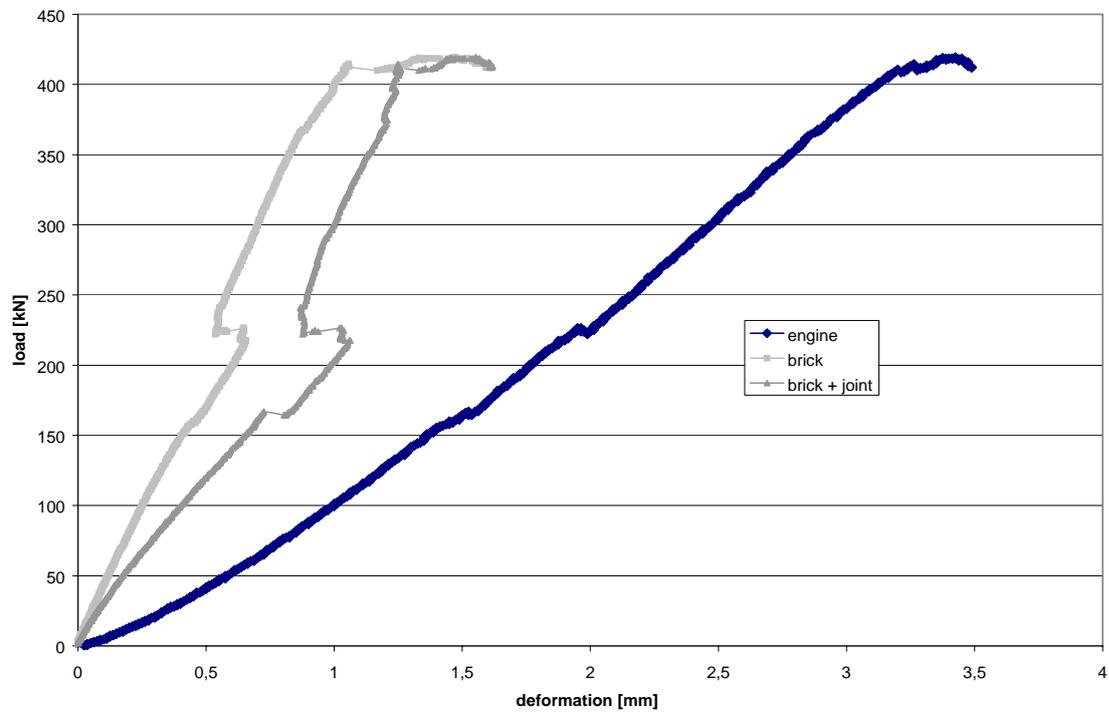
figure 13: load-deformation-behaviour of specimen MWK\_6

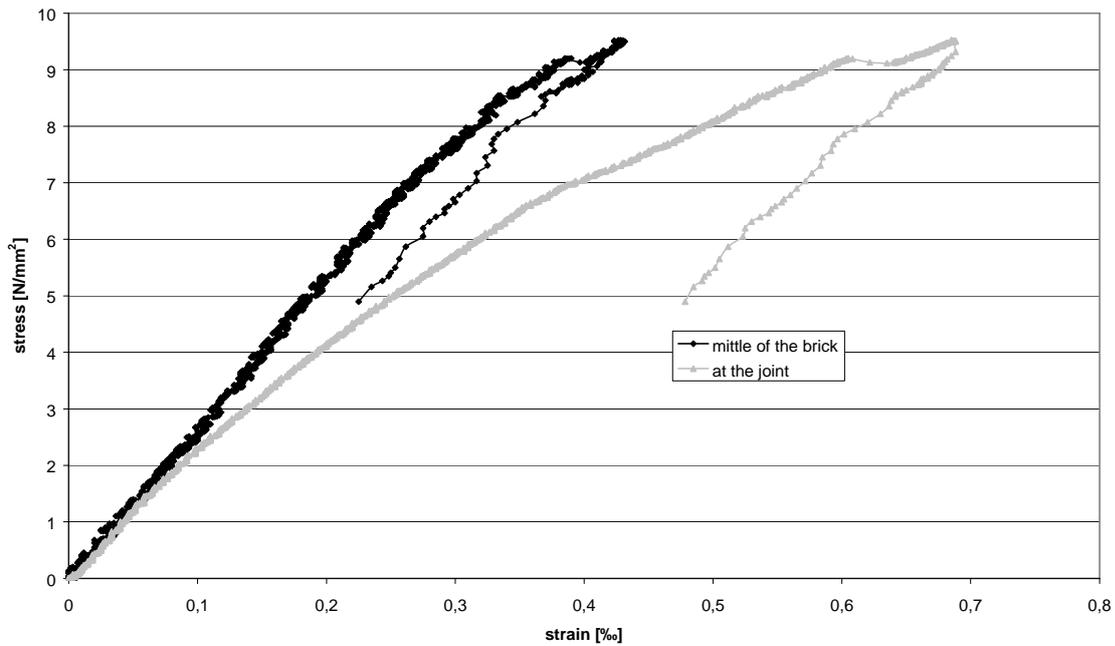
figure 14: horizontal strains of specimen MWK\_2

The strains, as obtained from these measurements, versus the stresses are shown in figure 14 and figure 15 for two selected specimens of the first and the second series. They depict the different behaviour of the specimens through the experimental setup (with and without a hinge).

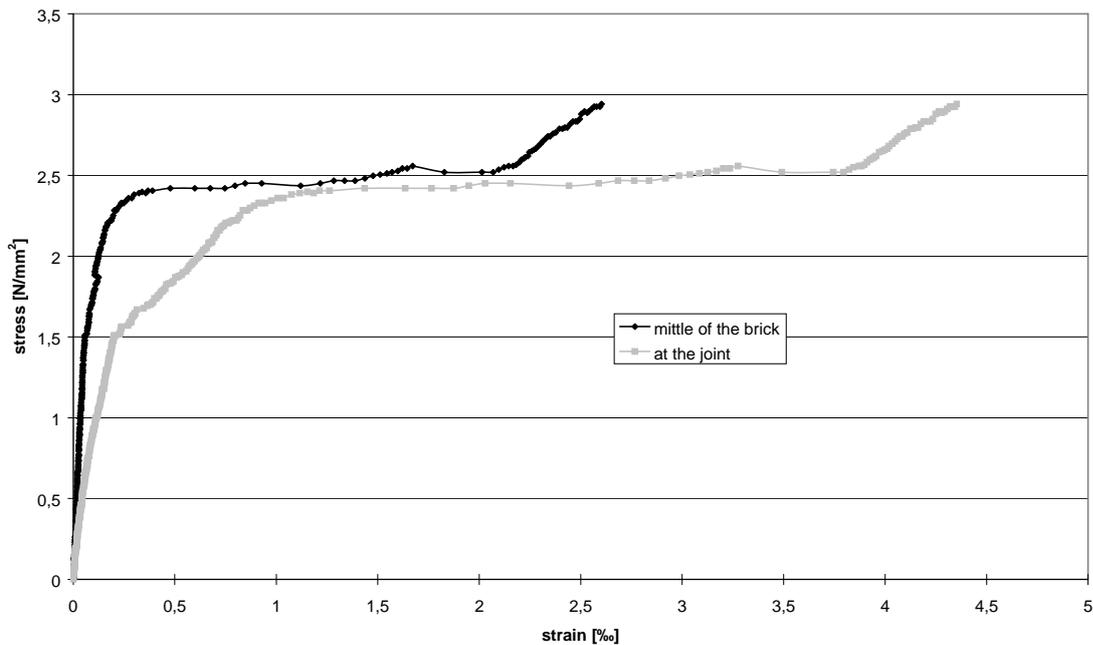
figure 15: horizontal strains of specimen MWK\_6
